# Improving Reliability in Molten Metal Temperature Measurement

**INDUSTRY****Metal Processing****SOLUTION****Non-Contact Temperature Measurement****EQUIPMENT****Two-color pyrometers and thermal imaging systems****CHALLENGE**

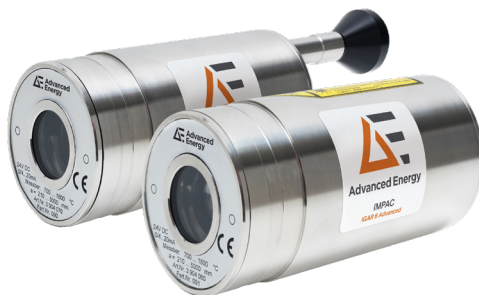
Impac® IGAR 6 Advanced Pyrometer

Advanced Energy ISR 6 Advanced and IGAR 6 Smart ratio pyrometers were installed to measure molten metal streams and critical process points in real time. Two-color technology helps compensate for emissivity changes and maintain measurement accuracy in dusty, high-temperature, and high-EMI environments.

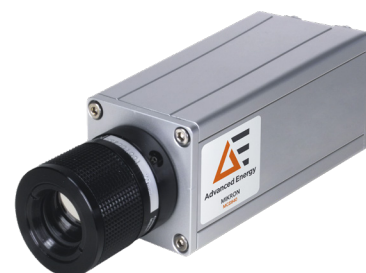
Mikron® MCS640 Thermal Imager

MCS640 thermal imaging systems were deployed to monitor ladles, furnaces, and transfer areas. Thermal imaging delivers continuous temperature visualization across critical assets, helping operators identify material defects, verify chamber and ladle temperature uniformity, and gain greater insight into process conditions in real time.
